PREVIOUS FLIGHT ANOMALIES BACKUP

STS-109 IN-FLIGHT ANOMALIES

STS-104 IN-FLIGHT ANOMALIES

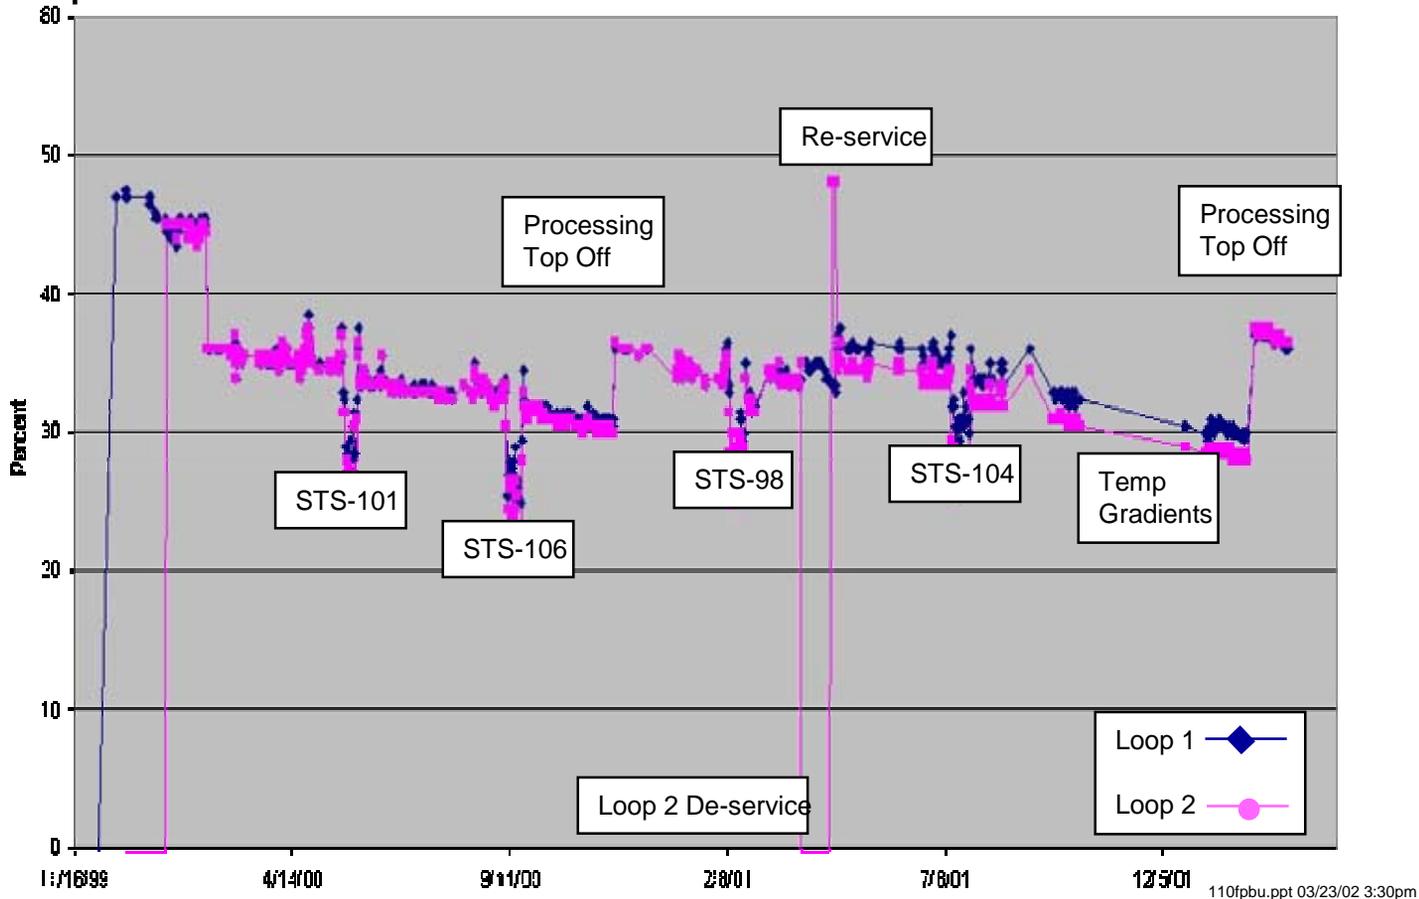
No leakage observed on OV-104s FCL accumulator quantities

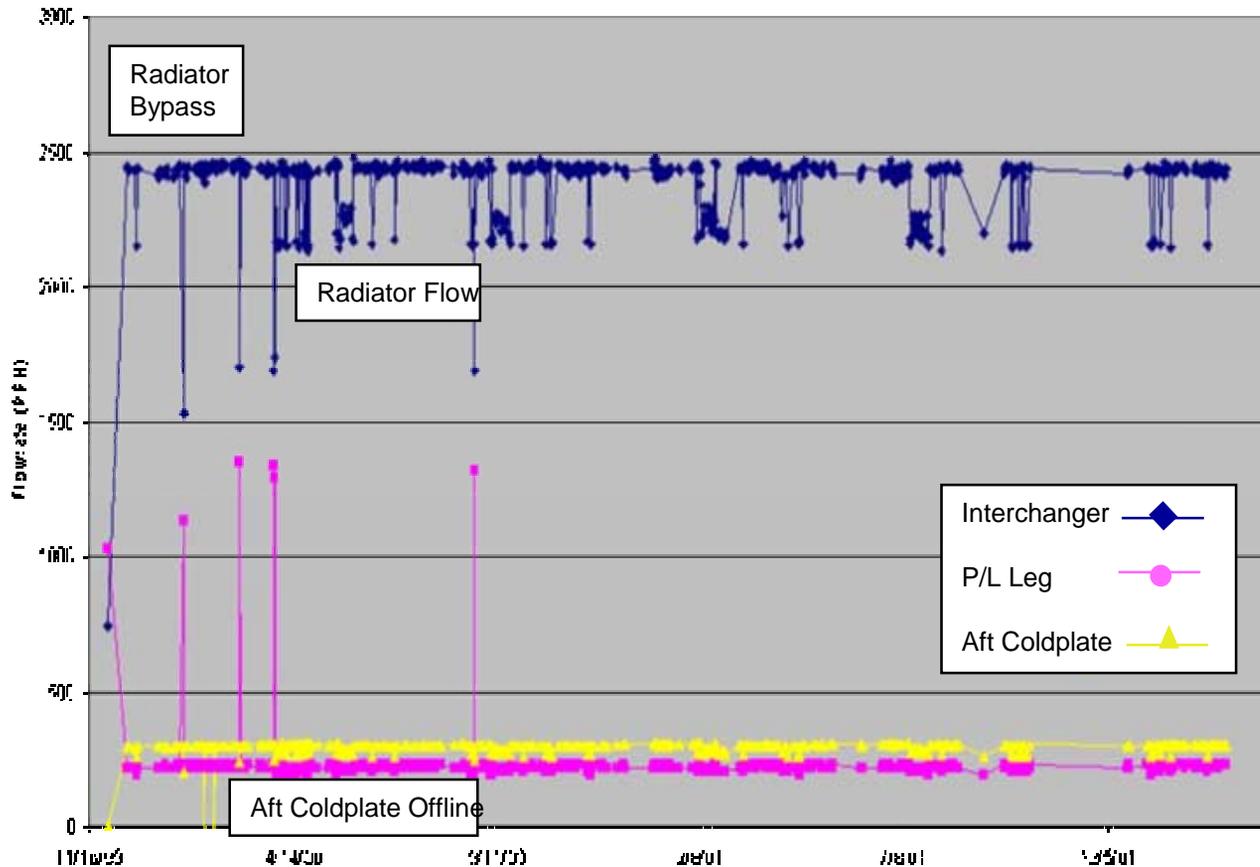
Freon Coolant Loop 1 flow rates showed no degradation

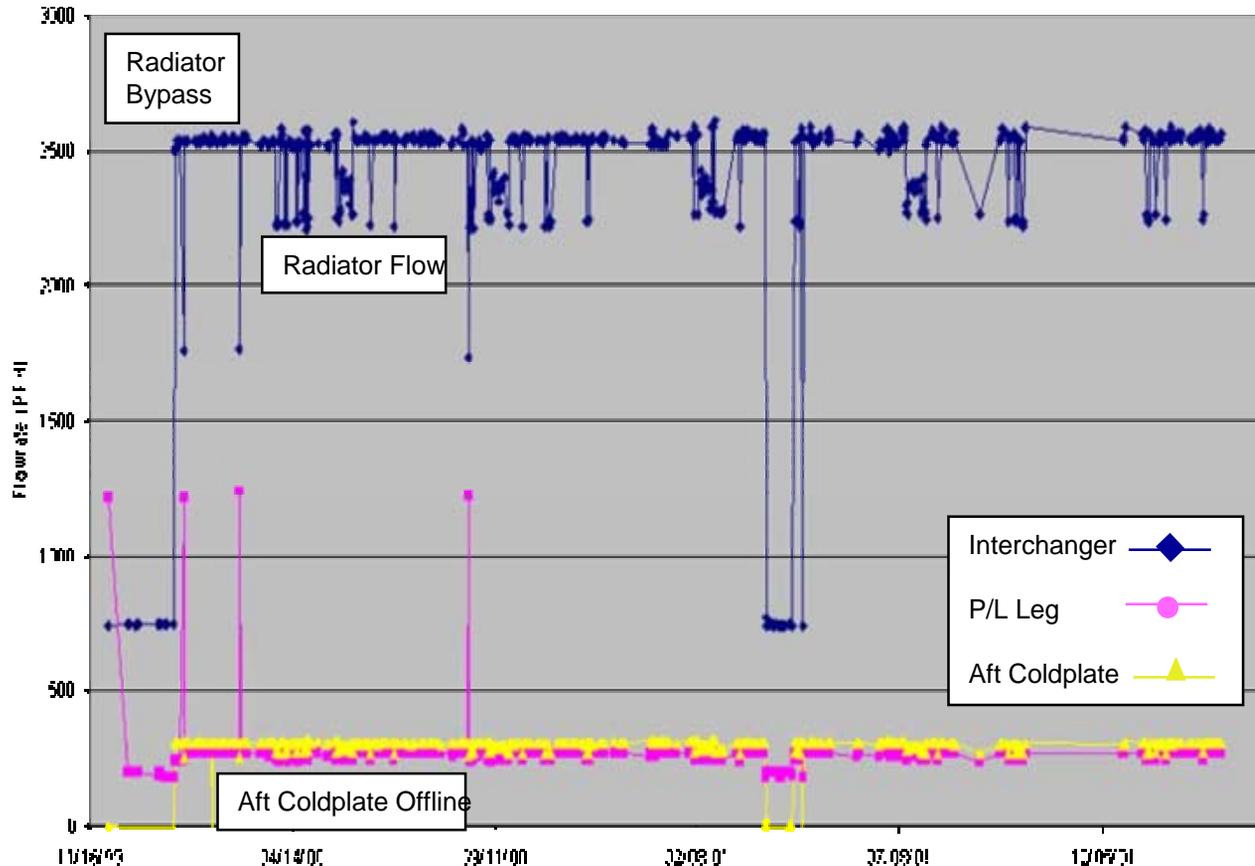
Freon Coolant Loop 2 flow rates showed no degradation

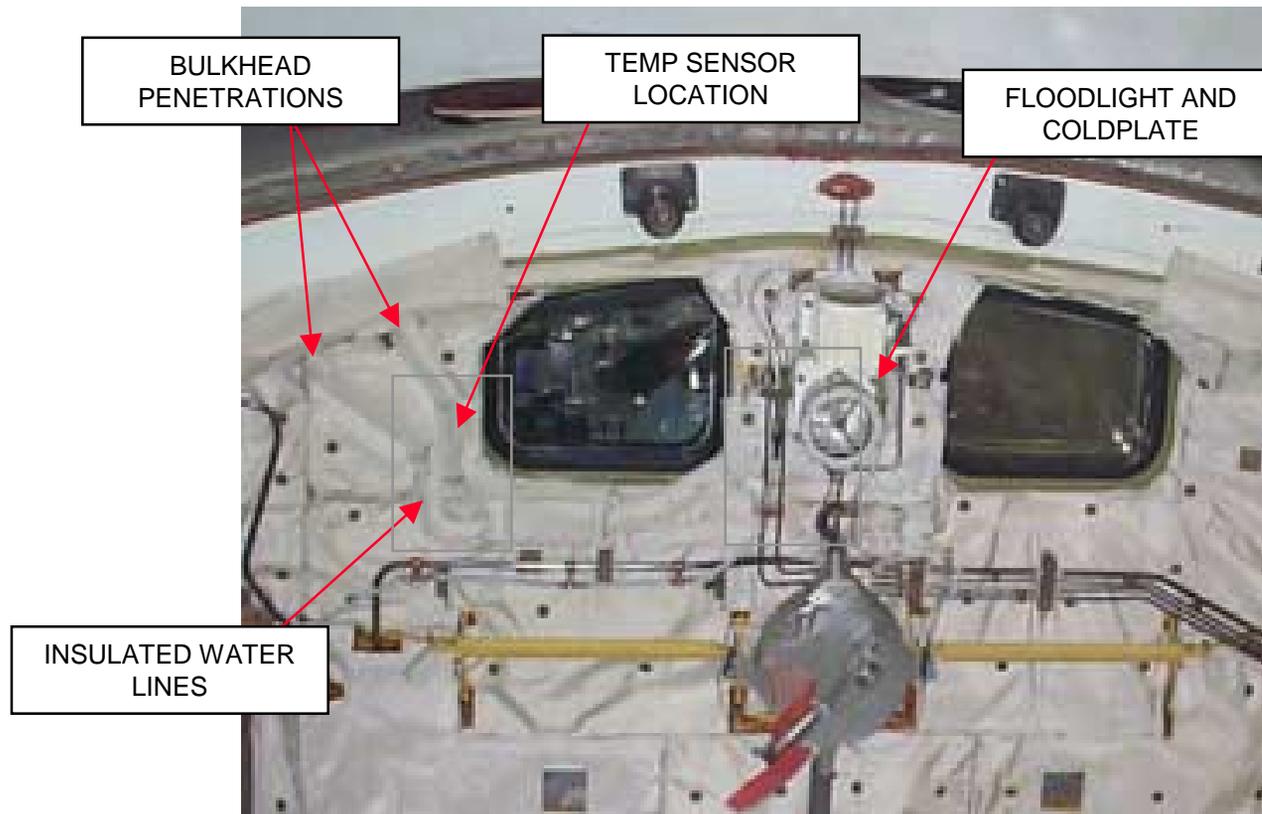
FORWARD BULKHEAD FLOODLIGHT, COLDPLATE AND WATER LINES

- Flood light coldplate water coolant loop 1 temperature dropped to 36°F during STS-104 at MET 1:17 hr

- Review of three previous OV-104 flights (all since last OMM) revealed temperature drop as low as 31°F
 - STS-104 temperature signature closely followed orbital cycling, indicating most likely cause was a problem with the line insulation

- Modification to remove bulkhead floodlight/coldplate and water lines planned for STS-114 flow

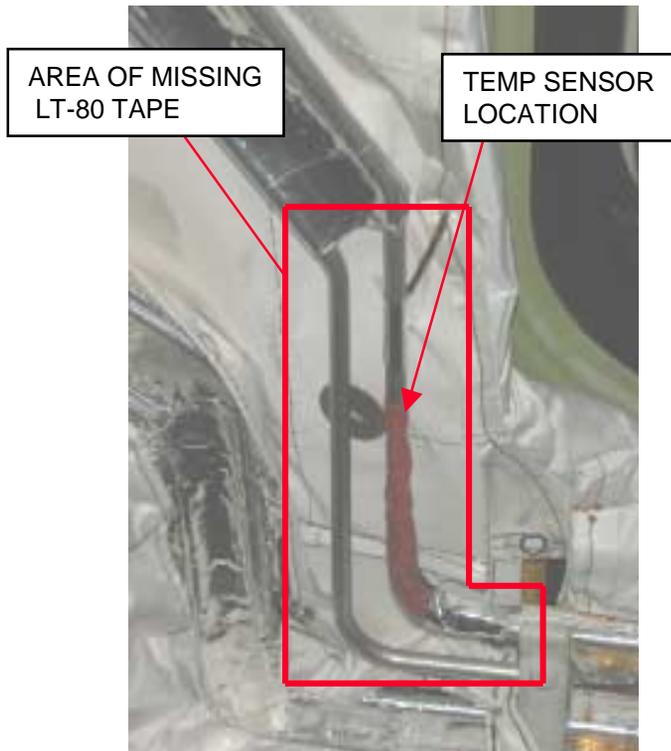
POST-FLIGHT INSPECTION

- Post flight inspection found improper thermal tape at area of temp sensor – subsequently corrected

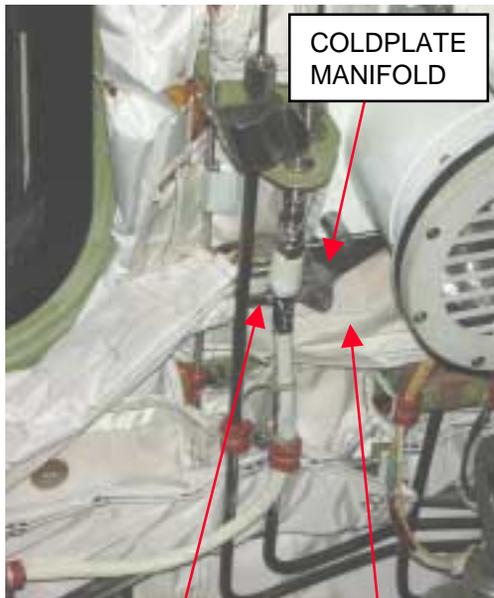
POST-FLIGHT INSPECTION

- Post flight inspection found improper tape and insulation at area of cold plate – subsequently corrected

MISSING LT-80 TAPE AND MLI COVER

TCS BLANKET UNDER WATER LINE AND MANIFOLD

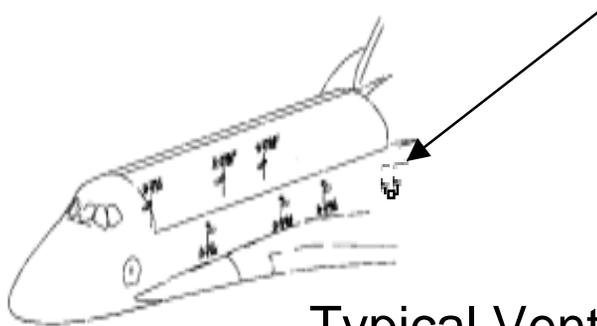
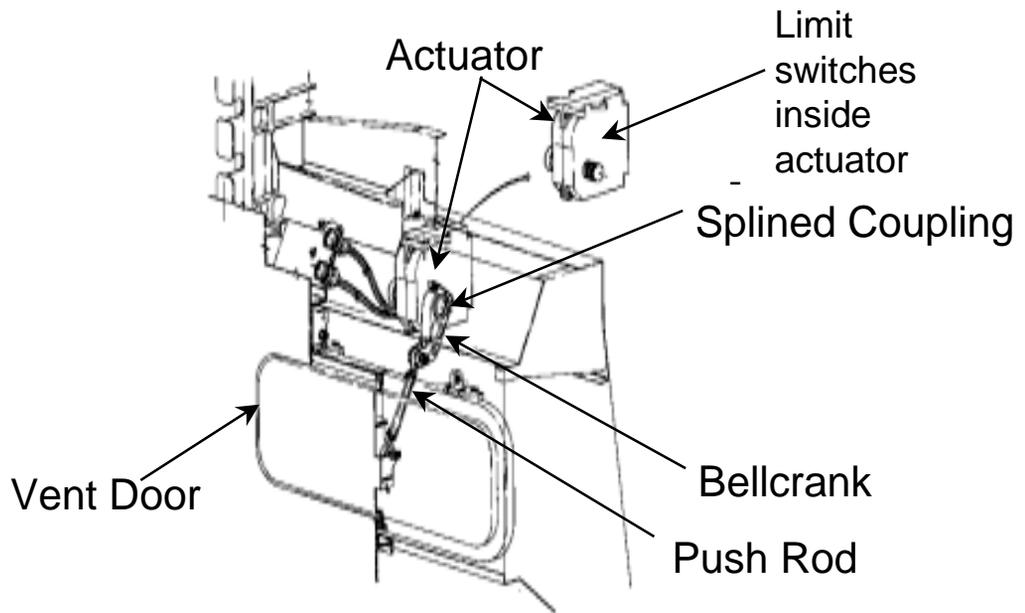
Location of Vent Door # 8 & 9 - AFT Fuselage

- Left hand vent doors 8 & 9 OPEN limit switch #2 temporarily failed off during entry

- Actuator was removed and replaced
- Newly installed actuator was successfully retested
- Removed actuator was sent to NSLD for TT&E
 - Most probable cause is a degraded limit switch
